# Fatigue tests of welded plate girders in bending, May 1965

Progress Report on the Fatigue Strength  
of Welded Plate Girders

FATIGUE TESTS OF WELDED PLATE GIRDERS IN BENDING

Fritz Engineering Laboratory Report 303.9

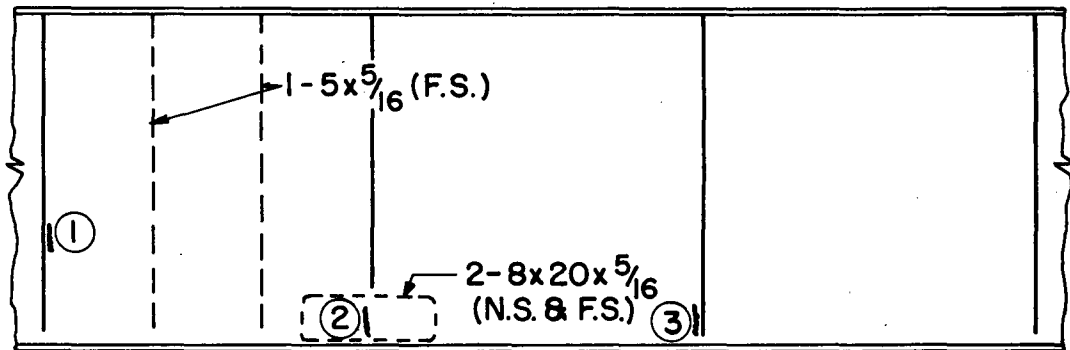
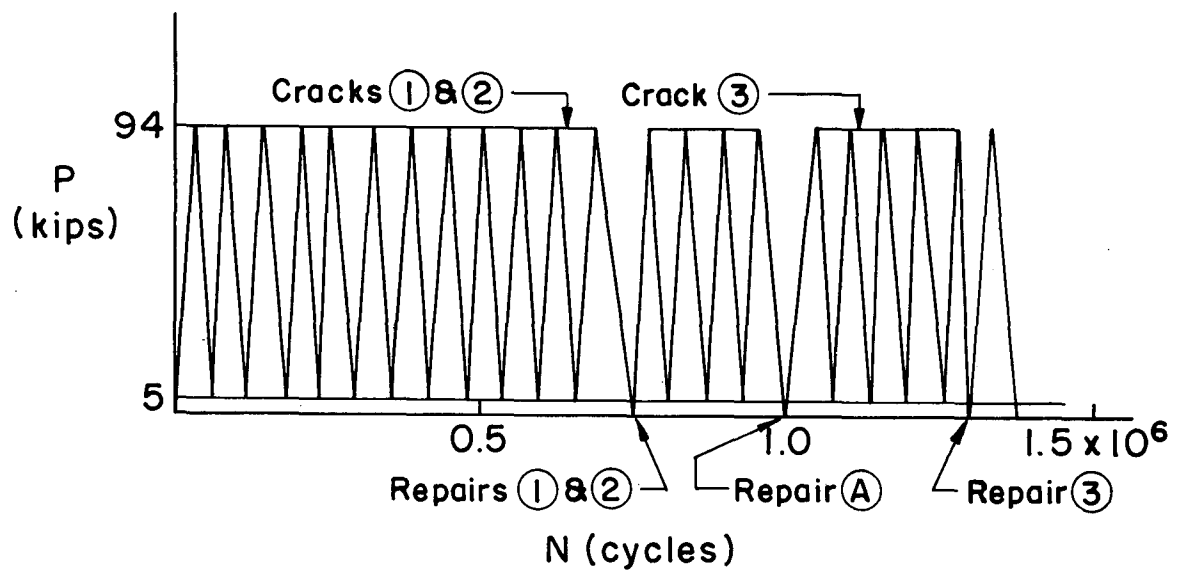
Fig. 6 Fatigue Testing of Girder F6

Fatigue testing proceeded at a measured rate of 262.5 load cycles per minute from 5 to 94 kips. At 600,000 cycles a pair of cracks, referred to as Cracks 1 and 2, were found on the far side of the web in test panel 1. Both cracks had initiated at the web-stiffener boundaries in the web, at the toe of the weld, and propagated parallel to the stiffener. After a total of 693,000 cycles, cracks were observed outside the test section in the web butt welds at  $x = \pm 82\frac{1}{2}$ . At 756,000 cycles it was decided that a repair would be made before relatively serious damage had been imposed by the butt-weld cracks. At that moment inspection revealed that Cracks 1 and 2 had propagated through the thickness of the web and had total lengths of 14 and 10 inches, respectively. (Close observation of Crack 2 indicated that it had not penetrated into the tension flange.) Final appearance and location of these cracks are shown in Fig. 6a. The history of loading is diagrammatically presented in Fig. 6b.

When testing was resumed, the cracks at the butt welds reappeared almost immediately. At a total of 869,000 cycles a crack appeared at the location of the repaired Crack 2 (referred to as Crack 2a). At 1,000,000 cycles testing was stopped for a careful inspection of all cracks. Plug samples were cut from the web butt welds adjacent to the flanges. When incomplete penetration of the welds was observed, the butt welds were completely removed and replaced. The voids which resulted from the inspection remained as cope holes. Along with these repairs (Repair A, Fig. 6b), an attempt was made to repair Crack 2a by gouging and welding.

Because of the excessive repairs a static test was performed before cyclic loading was resumed. Not long after pulsating was underway once again, Crack 2b appeared at the repair weld of Crack 2a at a total of 1,040,000 cycles. This crack was repaired shortly thereafter by first gouging and welding; then partially cutting away the intermediate stiffener and welding 8" x 20" x 5/16" doubler plates to the web at the location of the crack, as indicated in Fig. 6a.

Crack 3 was first observed along a stiffener (Fig. 6a) at 1,242,450 cycles. Before a repair was effected at 1,300,000 cycles this crack had grown to a total length of 5 inches. Repair (Repair 3) was made by first cutting away a small section of the stiffener, then gouging out the fractured material and welding.

One significant observation was the result of repairing the cracks. Both Cracks 1 and 2 of girder F6 were subjected to the identical treatment of removing the fractured material, depositing of weld material, and stiffening of the panel. Yet Crack 1 was successfully eliminated, but Crack 2 reappeared immediately. The cause of such a difference will be discussed later.

All cracks were repaired by first gouging out the fractured material with an air hammer chisel or grinding stone, or both, and then filling the cavity with weld material. In addition, panel 1 was stiffened

by welding two 5" x 5/16" plates to the far side of the web at the panel's one-third points, as shown in Fig. 6a. This overall repair of all cracks is indicated in Fig. 6b as Repairs 1 and 2.

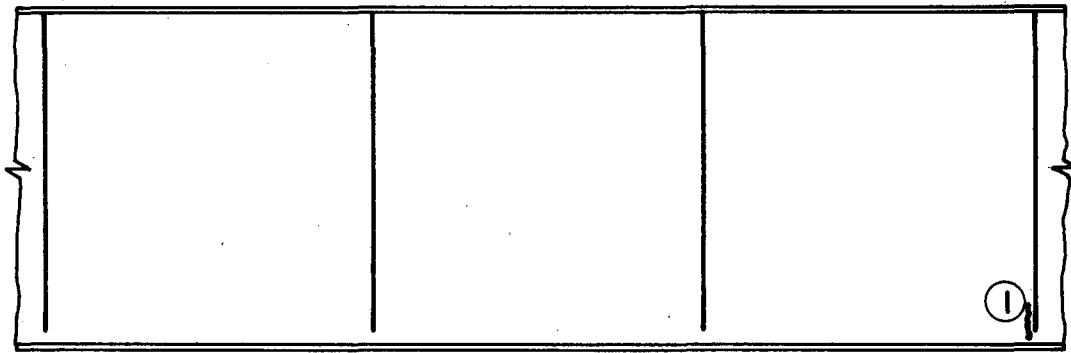
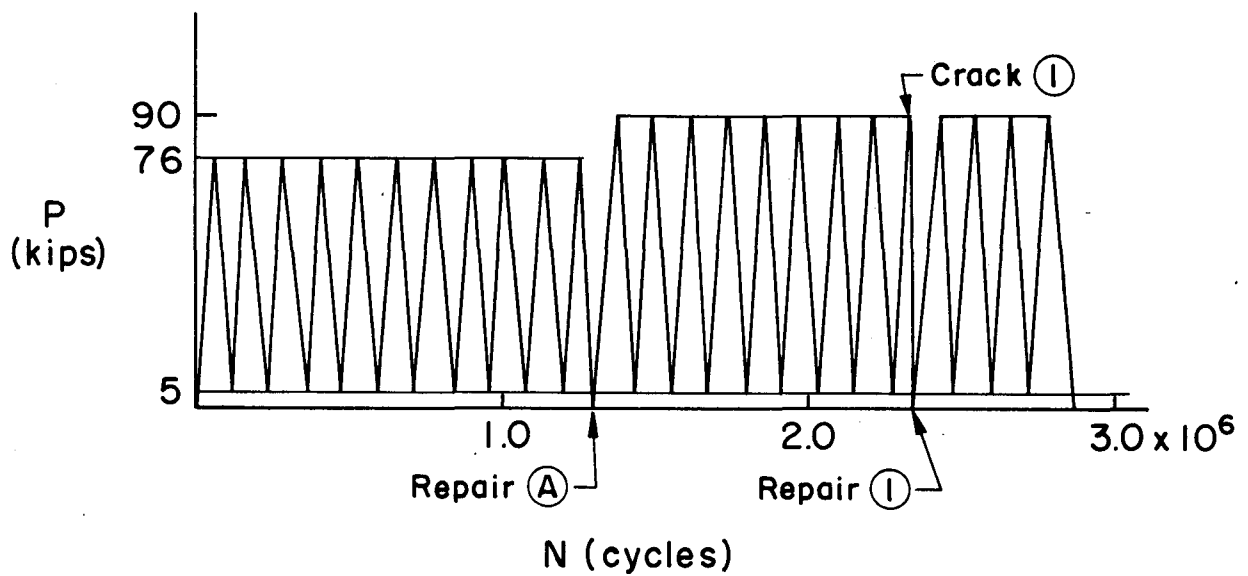
Fig. 8 Fatigue Testing of Girder F7

At 1,252,000 cycles after the beginning of fatigue testing, a crack was observed in the butt weld at  $x = -82\frac{1}{2}$ . Following this observation, testing was stopped at 1,300,000 cycles and inspection of the butt welds made by once again cutting plug samples from the welds. A complete repair, identical to that for girder F6, was found necessary for the butt welds.

With a load range of 5 to 90 kips, fatigue testing continued for 980,000 cycles (2,280,000 total cycles) before a crack was observed to form in the test section. The crack (Crack 1, Fig. 8a) was found along the lower part of the stiffener in test panel 3. It grew in length to about 4 inches before a repair was made at 2,330,000 cycles. Thereafter no cracks were detected in the test section. Due to cracks which appeared at the cope holes, testing was terminated at a total of 2,879,000 cycles.

When this repair (Repair A, Fig. 8) was completed a static test was run prior to the continuation of the fatigue test. At this time the

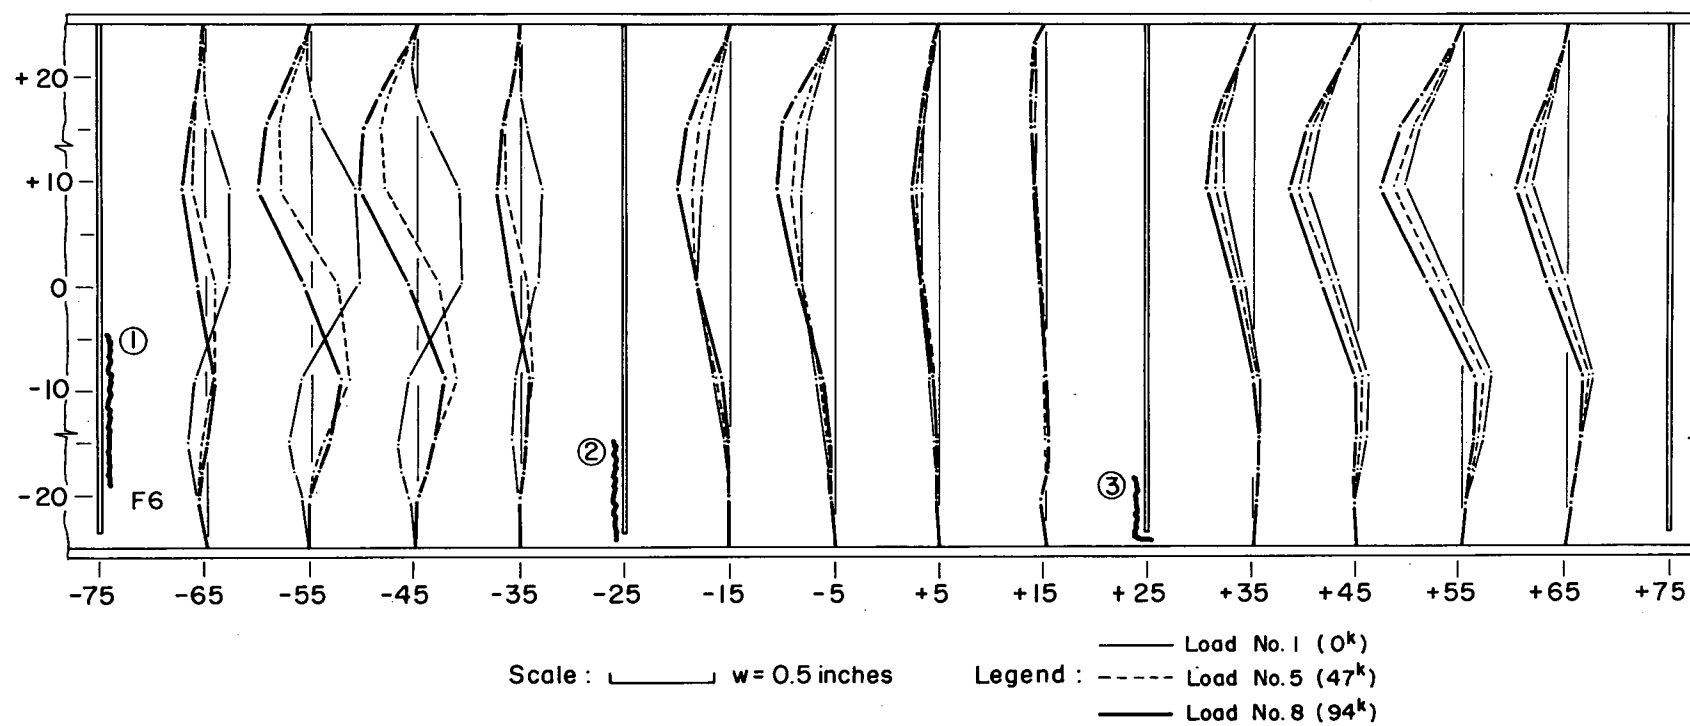
Fig. 10 Web Cross-Sectional Shapes, Girder F6

The deflected shape for panel 1, girder F6, differed from the common case in that large relative web deflections between the test loads occurred not only in the compression zone, but also in the tension zone (Fig. 10). The magnitudes of these movements were about 2-1/2 times the web's thickness for the compression zone and approximately equal to the web's thickness for the tension zone. Even at only a short distance (6-1/2") away from a stiffener ( $x = -75$ ), the relative deflections were found to be unusually large below the girder's neutral axis. The reason for such unusually large movements for this panel is the shifting of the deflected position of the web from one side of the vertical to the other during loading. This shifting movement did not take place for the other two test panels of girder F6, nor did it take place in any of the panels of girder F7 (Fig. 9).

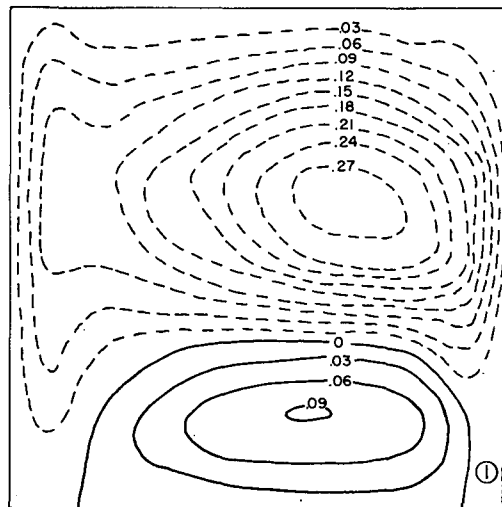
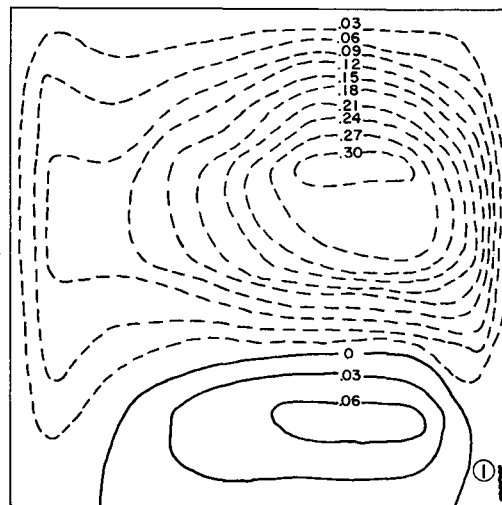
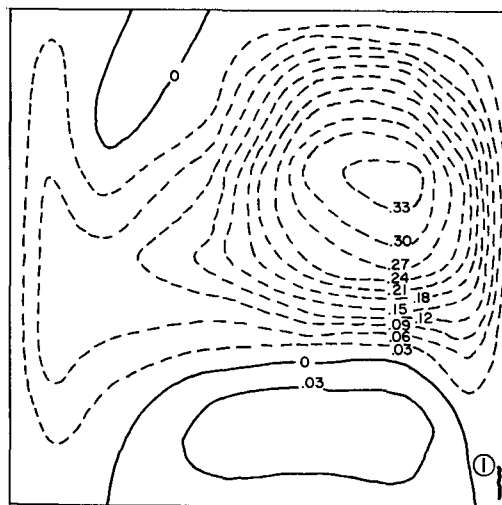
Fig. 11 Web Deflection Contours, Girder F7

A review of Fig. 11 indicates that the upper portion of panel 3, girder F7 was far from being plane at zero load. As the load was increased, deflections changed gradually and practically maintained the same pattern. By the decreasing of contour lines in the lower part of the panel, it is evident that the web was being straightened as load was applied. In the area where Crack 1 formed, there was little deflection of the web.

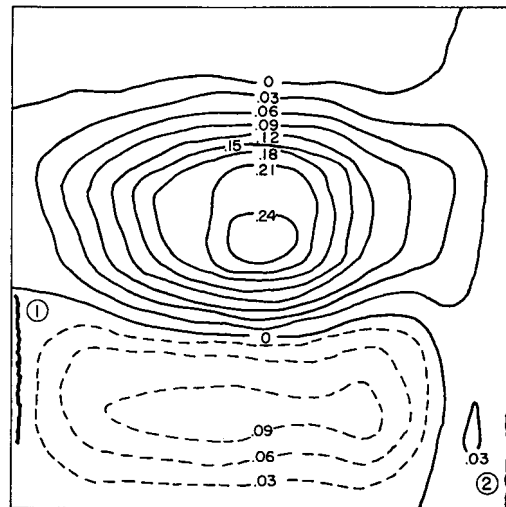
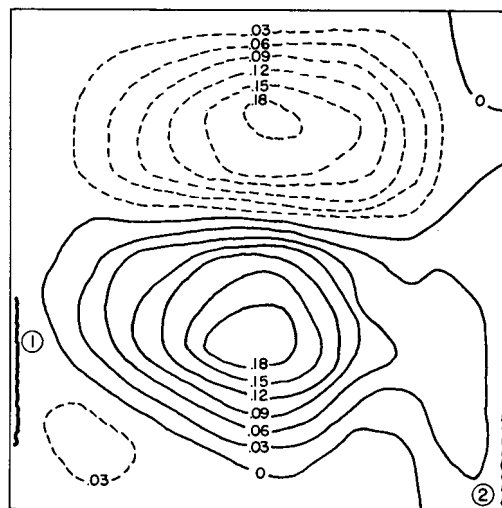
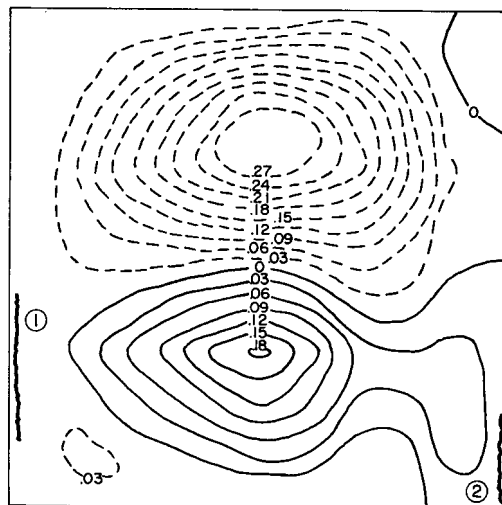
Fig. 12 Web Deflection Contours, Girder F6

From the deflection contours for panel 1, girder F6 (Fig. 12), the shifting movement of the web from one side to the other can clearly be observed. After the shifting between zero and 47 kips, the pattern of deflection was consistent, with only changes in the magnitude of deflection. Contrary to the common pattern of Fig. 11, intense contour lines appeared in the lower region of the panel, thus indicating relatively large web deflection in the tension zone. All these imply serious web movement, even near the boundary, and was observed so during testing. However, in the vicinity of Crack 2, the web almost remained stationary.

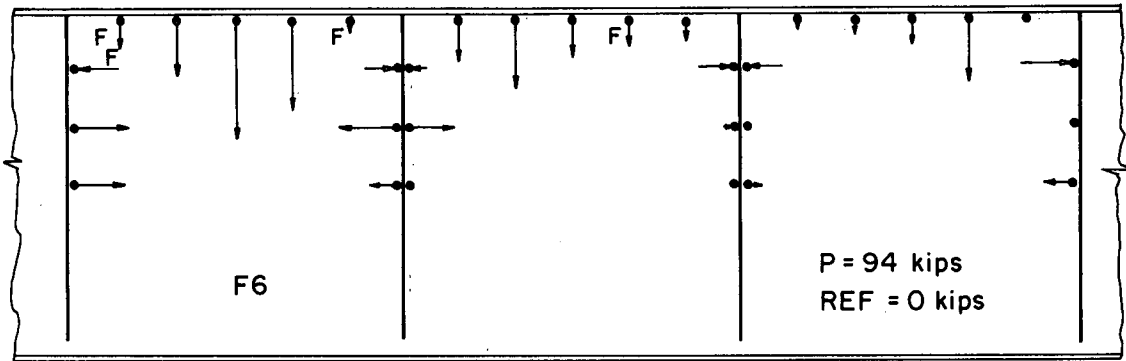
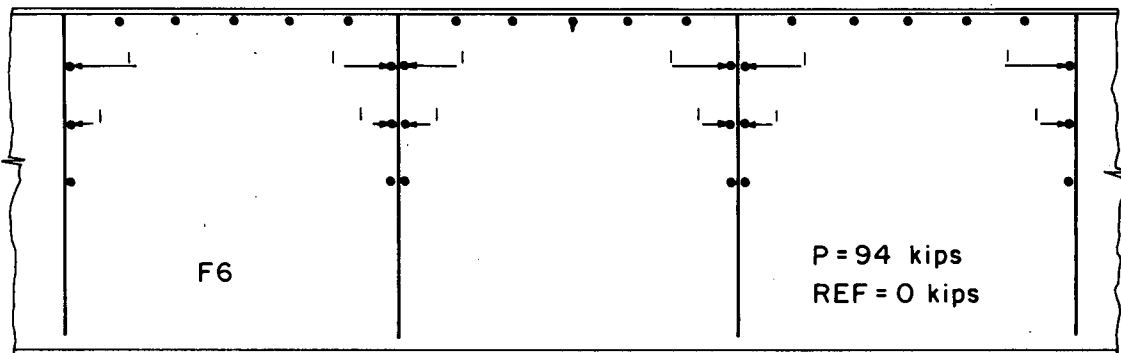
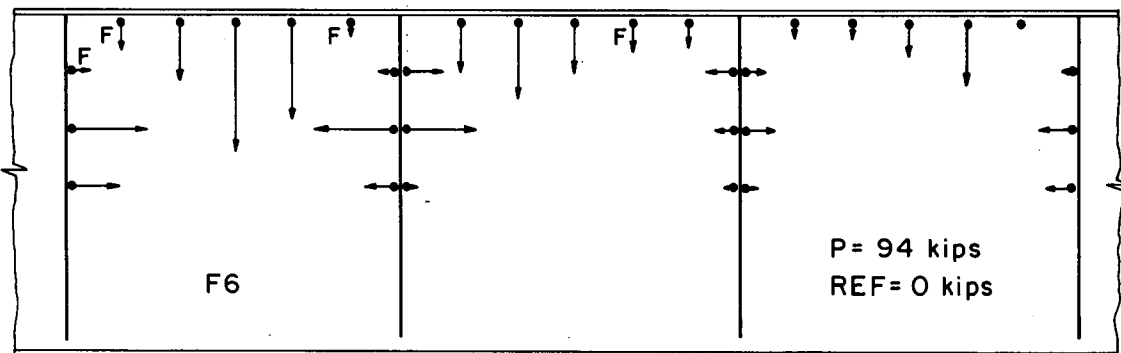
Fig. 15 Web Stresses Normal to the Boundary, Girder F6

Additional proof is provided by Fig. 15c for the compression zone of girder F6. Values of the plate bending stress at points below the neutral axis were not available prior to the formation of Cracks 1 and 2. However, after 1,000,000 cycles of load, these stresses were calculated to be in the order of 3 ksi for panels 2 and 3, where the web deflections were small. In order to obtain an evaluation of the plate bending stresses in the lower portion of panel 1 before the formation of cracks, it was necessary to use an approximate approach.

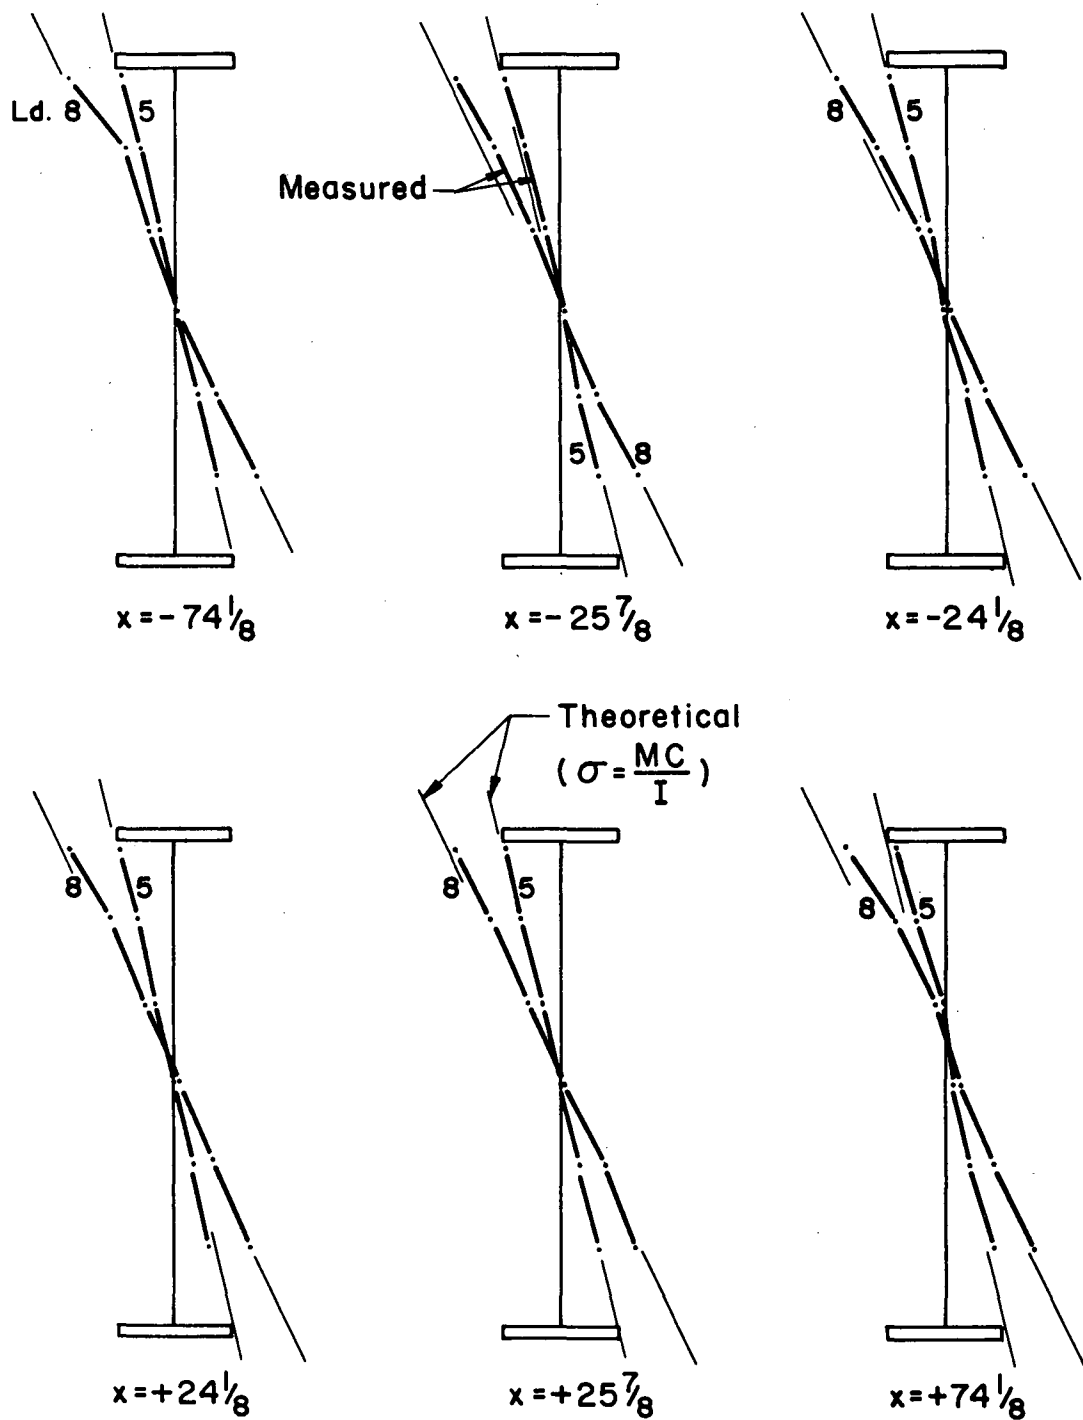
Fig. 16 Cross-Sectional Distribution  
 of Web Membrane Stresses, Girder F6

A review of the web membrane stresses, Figs. 16 and 17, reveals that at Cracks 2 and 3 of girder F6 and Crack 1 of girder F7 these stresses were about 16 ksi. Compared with the negligible secondary bending stress, it appears that the tensile membrane stress is dominant in the formation of fatigue cracks.

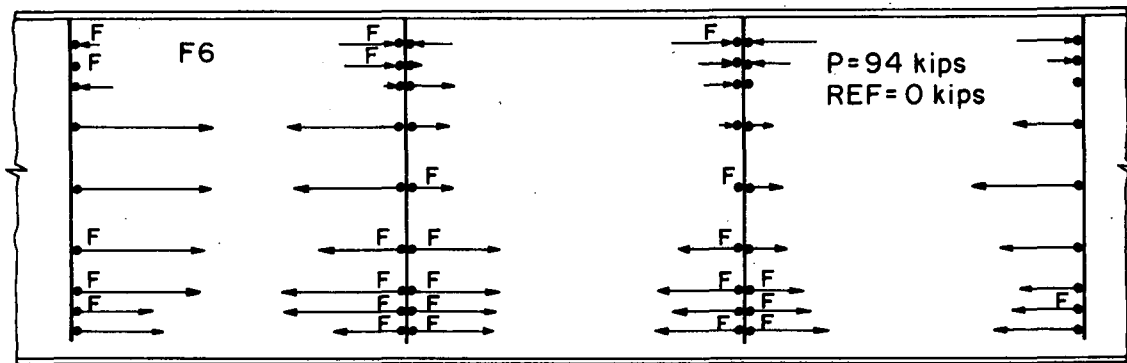
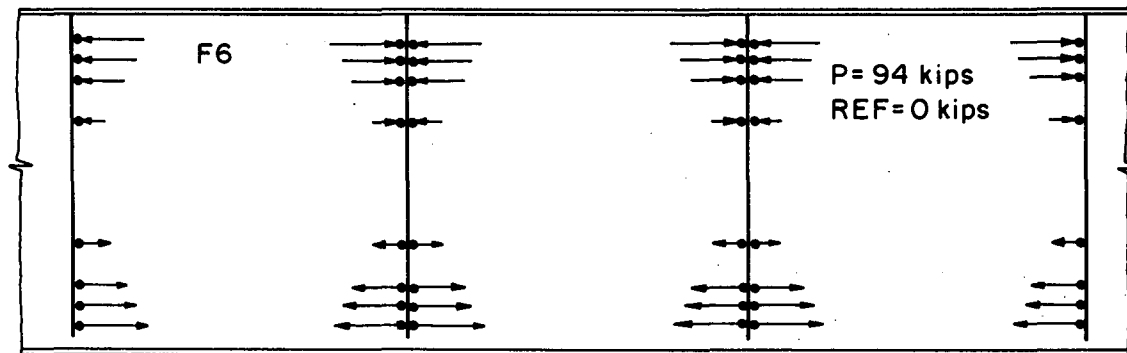
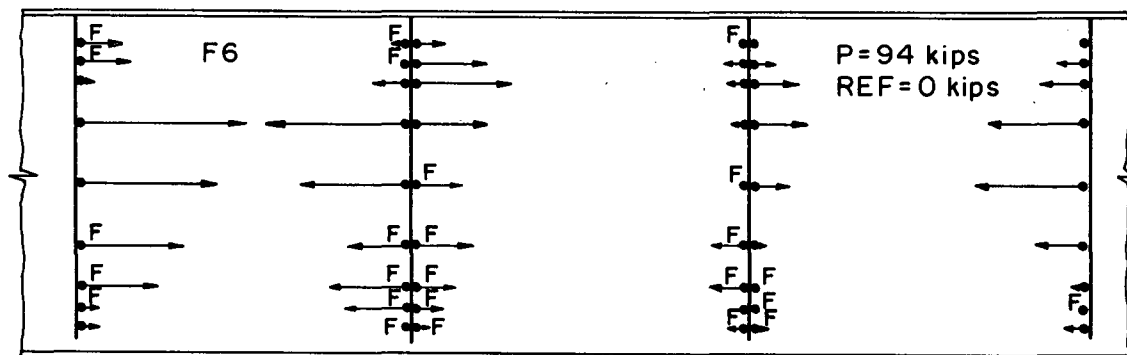
Fig. 20 Approximate Web Stresses Normal to the Boundary, Girder F6

From this, the secondary bending stresses were calculated at the toe of the fillet welds. These stresses are shown in Fig. 20 along with the approximate membrane ( $M_c/I$ ) and resulting surface stresses. The magnitudes of the plate bending stress for panel 1 were highest (25 - 35 ksi) in the upper part of the web, yet Crack 1 initiated about 9 inches below the neutral axis where the plate bending stress was about 20 ksi.

A further look at the stress picture in the vicinity of Crack 1, girder F6, indicates that the combination of secondary bending stress of about 20 ksi and tensile membrane stress of about 7 ksi resulted in a condition of stress which, most likely, was the cause of Crack 1. However, this condition does not seem to be the general case for bending girders, because large web deflections in the tension zone of the web are uncommon. Thus, in general, plate bending stress has little effect on the formation of fatigue cracks in plate girders subjected primarily to bending, whereas tensile membrane stresses have a dominant effect.
